## PIC18F87J10 Family Rev. A3 Silicon Errata

The PIC18F87J10 family parts you have received conform functionally to the Device Data Sheet (DS39663D), except for the anomalies described below. Any Data Sheet Clarification issues related to the PIC18F87J10 family will be reported in a separate Data Sheet errata. Please check the Microchip web site for any existing issues.

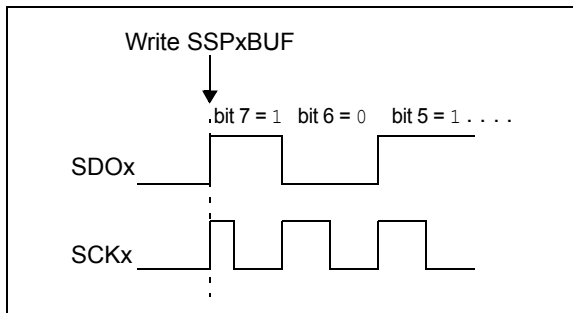
**FIGURE 1: SCKx PULSE VARIATION USING TIMER2/2**

When the SPI is using Timer2/2 as the clock source, a shorter than expected SCKx pulse may occur on the first bit of the transmitted/received data. See Figure 1.

### Work around

To avoid producing the short pulse:

1. Turn off Timer2.
2. Clear the TMR2 register.
3. Load the SSPxBUF with the data to be transmitted.
4. Turn Timer2 back on.
